- Concrete Forensics - Understanding Petrographic Analysis
- MJA Project Watch
- New Hire
- Win a \$100 Gift Card

What is a Petrographic Analysis?

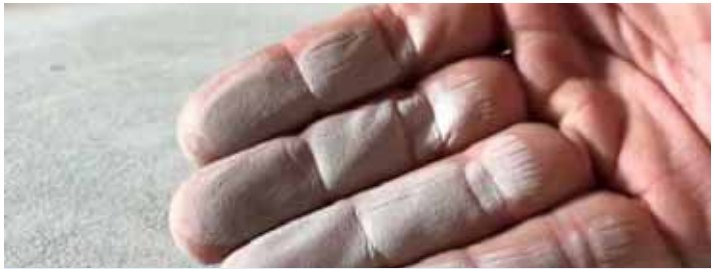
Excessive dusting of a concrete floor ²

What if the concrete floor in your new building has a network of cracks running through it? What if, when you run your hand over the surface of the concrete floor in your new warehouse, you can wipe up a lot of gray dust?

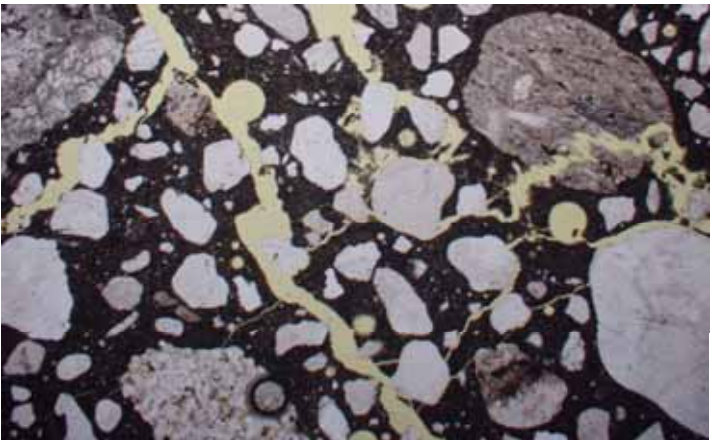
Distribution and sizes of entrained air voids within cement paste³

Often an Air Void Analysis (ASTM C586) is also completed. This will provide detailed information about the relative composition and distribution of course and fine aggregate, cement paste, and entrained and entrapped air.

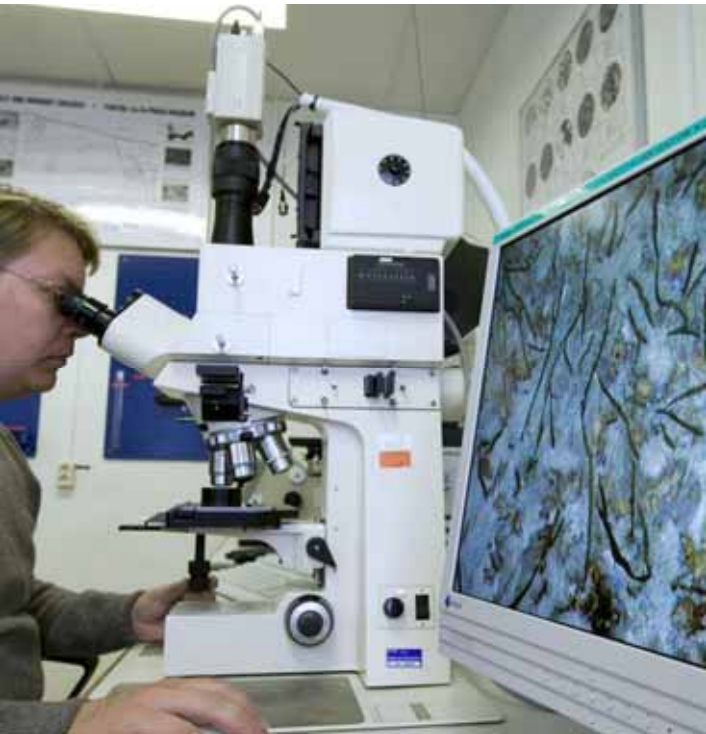
A researcher using thin section petrography for analysis⁵

During the petrographic analysis the petrographer will do a microstructural examination of the concrete. They look at the paste and aggregate in the concrete with both optical and scanning electron microscopes.

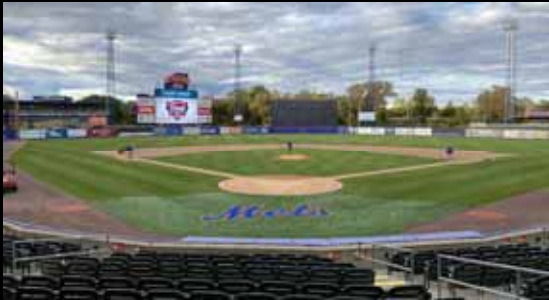
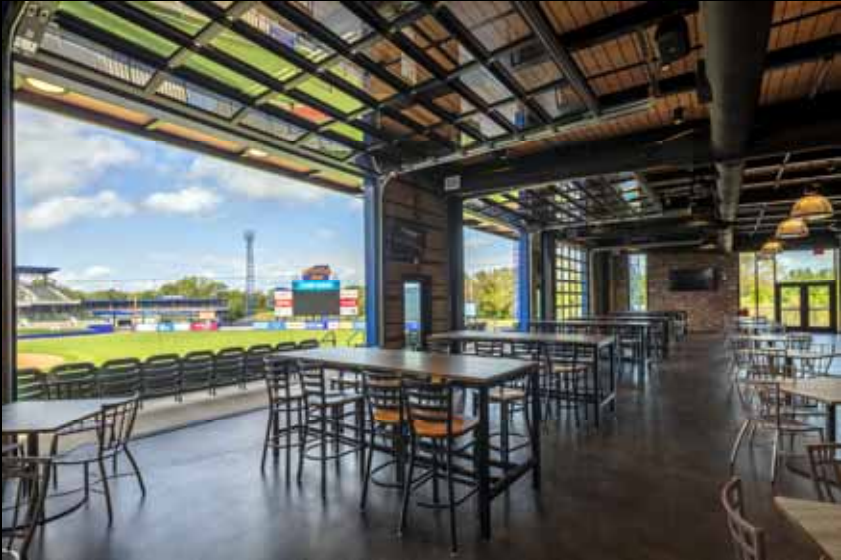
NBT Bank Stadium

- Metropolitan Club
- 6,250 sq. ft. of concrete flooring
- Stained and sealed
