THE CONCRETE FLOOR REPORT

THE FINISHING TOUCH

Filling the Control Joints in your Concrete Floor¹

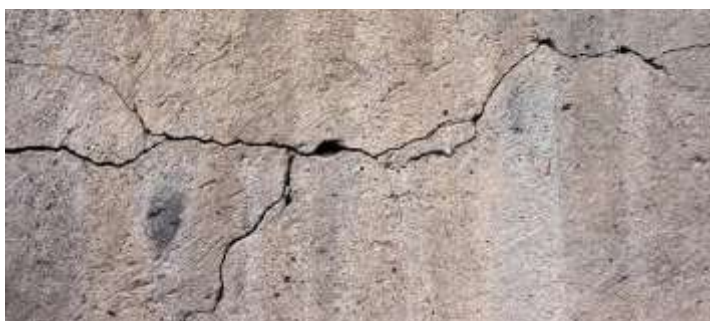
Random cracks in a concrete slab due to drying shrinkage²

As concrete cures, the moisture loss after the concrete has hardened can lead to volume reduction or drying shrinkage. Drying shrinkage is the root cause of random cracking in most concrete floor slabs. Unfortunately, this is a very common and frustrating characteristic of concrete.

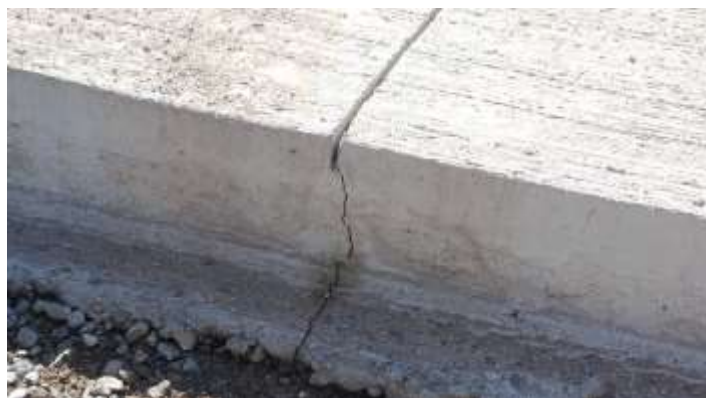
The cracking due to drying shrinkage happens along the weakened plane of the control joint cut in the slab³

Control joints are a widely used method to guide the cracks that are caused by drying shrinkage of a concrete floor slab. The control joint creates a weakened plane in the concrete slab which helps determine the spot where the concrete cracks.

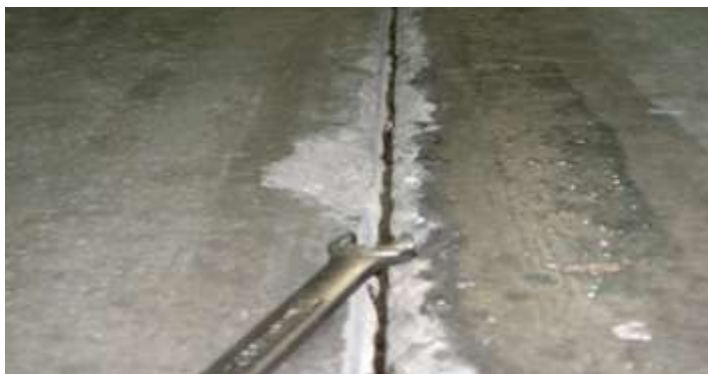
Control joint damage due to forklift traffic 4

Changes in warehousing demands and forklift design have caused floors to be subjected to much more frequent traffic and much heavier loads than in the past. The heavier traffic places larger load forces on the edge of the control joints. This force

causes edge chipping which can become a hazard to both foot and wheeled traffic. Unfortunately, the soft filler did not solve the problem of the damage to the edges caused by the increased forklift traffic.

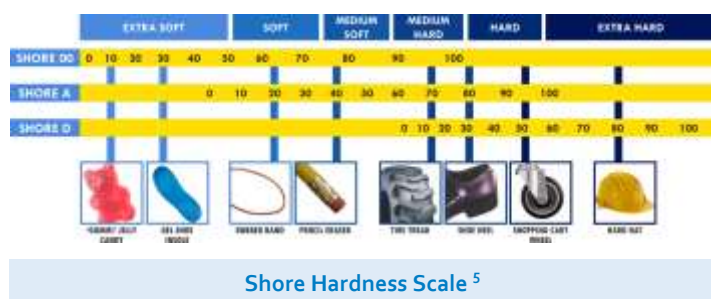
Another characteristic that is important in terms of protecting the wall of the joint from chipping is the Shore Hardness. Both types of semi-rigid joint fillers can be formulated to have a Shore A Hardness of 80 to 85. Shore Hardness is a relative scale. It is measured by pressing a needle down on the surface of the cured filler and looking at how the material resists the indentation. Industry standards dictate that the fillers have a minimum hardness of 80. Materials with this hardness level will support the edges of the control joint and prevent the edge from chipping. If the floor is exposed to really heavy loads, the epoxy may be the filler to use.
