THE CONCRETE FLOOR REPORT

A Publication of The MJA Company, Serving New York Since 1988

Cold Weather Concreting: The Unseen Dangers

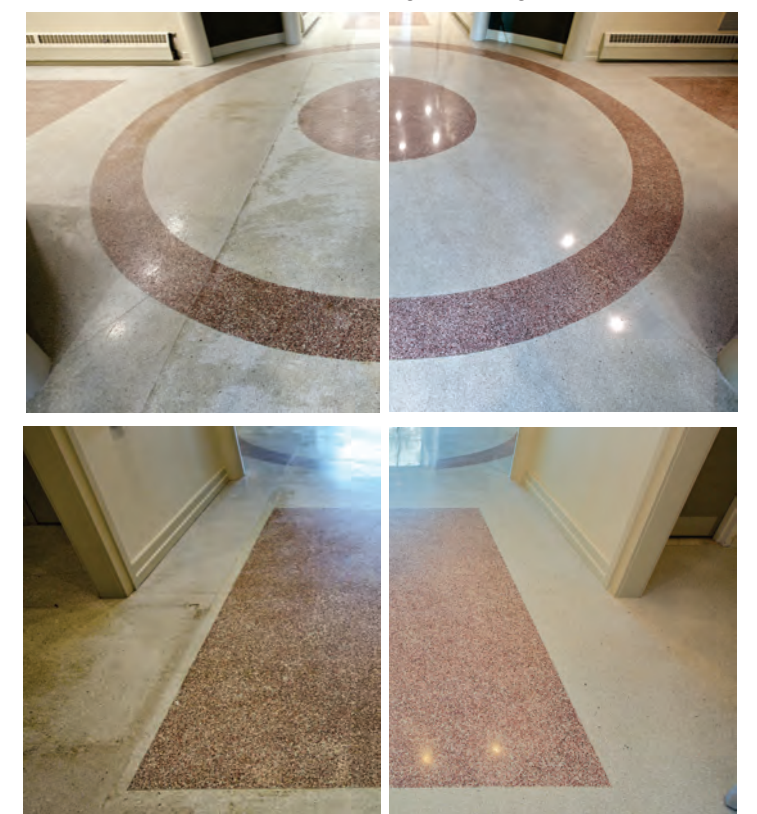
Before TerrazzoShine: Mechanical deterioration, chemical attack, residue, and contamination caused by cleaning and polishing agents diffuse and absorb light, reducing the floor’s reflective characteristics.

After TerrazzoShine: The TerrazzoShine process corrects most mechanical deteriorations, restores areas damaged by chemical attacks, and removes residue, leaving a clean, smooth, polished, light-reflecting surface.

The MJA Company’s environmentally-friendly TerrazzoShine thermal sealing process eliminates the need for costly, time-consuming stripping and waxing. You’ll save time and money with TerrazzoShine.
