# THE CONCRETE FLOOR REPORT

## PREVENTION IS THE BEST CURE

### Surface Discoloration of a New Concrete Floor

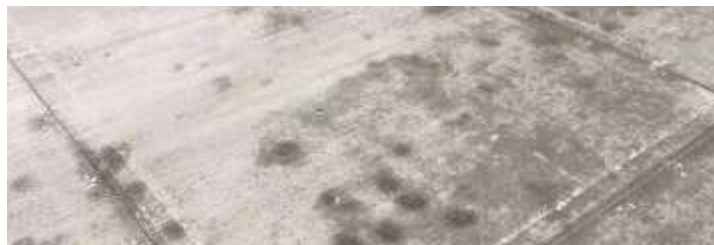
Example of blotchy and discolored concrete

Additionally, there is another dimension to the problem. It is that there can be a lot of variations in what occurs on the surface of the concrete. The discoloration of the concrete surface can be gross changes over large areas of concrete, blotches over some areas, or smaller spotty or mottled areas on the surface.

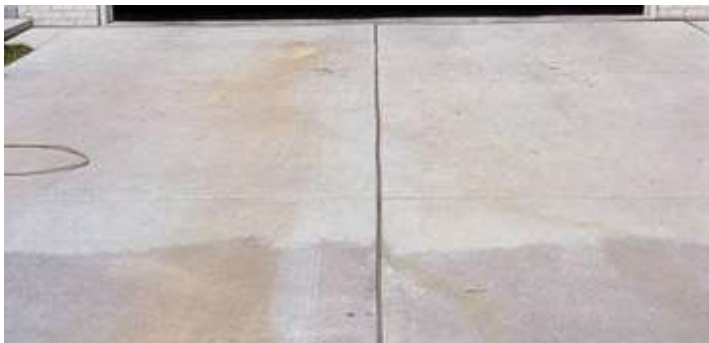
The advantages of using calcium chloride are obvious. On the other hand, if the amount of calcium chloride used in the concrete mix is too high, it can cause problems. The increased percentage will inhibit the reaction of the ferrite compounds in the concrete and the surface will be darker.

Discoloration of a slab with the darker area having the calcium chloride additive while the area closer to the door did not.<sup>2</sup>

How can this discoloration be prevented? It is very important that all of the batches that come to the site are consistent in terms of the percentage of calcium chloride. Another consideration is that the percentage used should not exceed the amount as recommended in the ACI specifications.

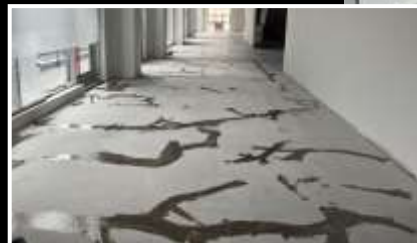
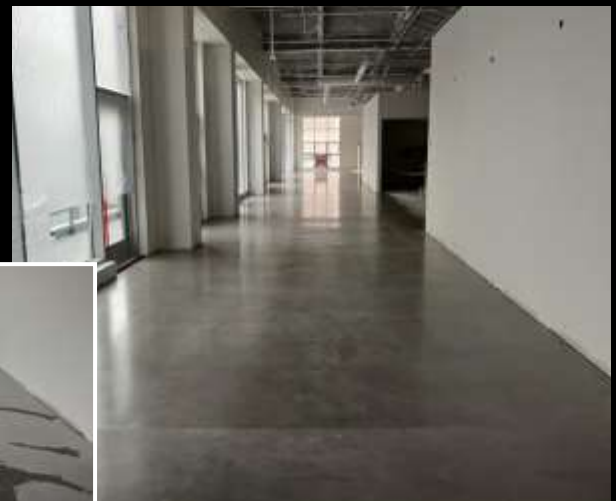
## City Center 2nd Floor Renovation

Preparation of the 5,100 sq. ft. surface included crack repair, control joint filling, and extensive surface pitting repair. This was followed by a multistep polishing system to a 800 grit polish, using Retroplate as the hardener and Retroguard as a protecting treatment to the entire concrete surface.

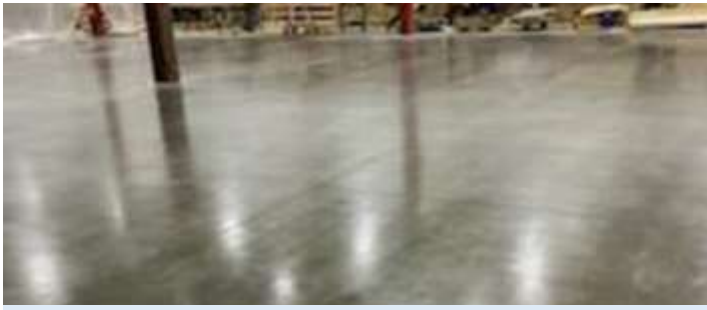
A concrete slab surface becomes “burnt” if, while finishing, the surface becomes too stiff to finish in a normal fashion. Because of this, the finishers have to vigorously trowel the surface to finish it. The vigorous troweling forces the water out of the surface layer which, reduces the water content in that portion of the slab and this causes the surface to darken. The more vigorous and extended the troweling, the darker the surface becomes. This process can result in the concrete being quite dark, sometimes even bordering on being black in color.

This concrete was overworked and thus the surface is darkened.

The preventive measure for each of these problems is having language in the specification to state that the concrete finishers should use plastic blades on their power trowel and not burn or overwork the concrete surface.

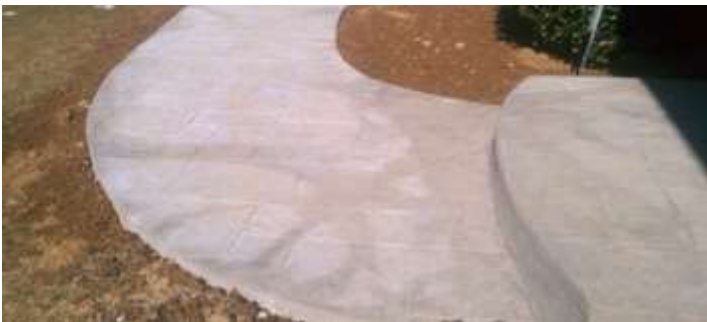
Quite often a covering material is used to cure a concrete slab. This is a very effective method! Problems occur when the covering is placed so the cover is not consistently in contact with the surface. If this is the case, the surface can appear mottled once the covers are removed.

What happens is that there is a difference in how the water evaporates out of the surface of the concrete in the air pockets above the slab when the cover is not in direct contact. This causes differences in the cement-water ratio in that part of the slab. This causes light and dark mottling to appear on the surface. If this is repeated over all sections of the slab, this leads to a very mottled surface.

Discoloration due to curing covers that are placed on the concrete, some areas in contact with the concrete and others that are not.<sup>4</sup>

The way to avoid this problem is to make sure that the cover is in contact all over the slab, and remains so, for the entire curing process as per specifications.

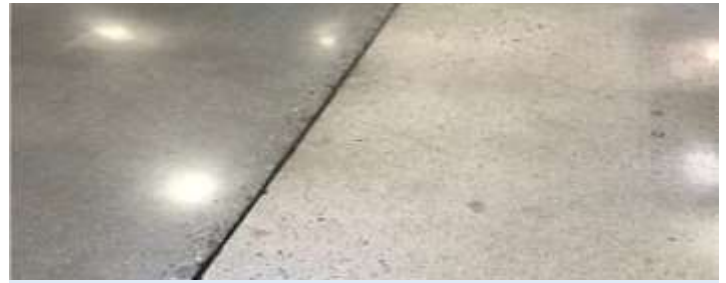
Concrete is a very complex mixture. The type of cement, mineral admixtures, and sand can affect the color. Any variation in one of these components will cause a difference in color from one part of a floor to another. Any change in the concreting practices or even getting the same mixture from different plants can cause color problems.

Two separate pours in the same room, possibly the result of the contractor getting concrete from two different plants/locations.<sup>5</sup>

The picture above shows how drastic the difference can be from a change in the concrete delivered to a site. In order to avoid these problems, consistency is the key!
